## Docket No. 272 - Development and Management Plan Inspection

## **Segment 2a Inspection**

Date: October 5, 2006

Location: Segment 2a – Beseck Switching Station to Cheshire/Hamden Town Line

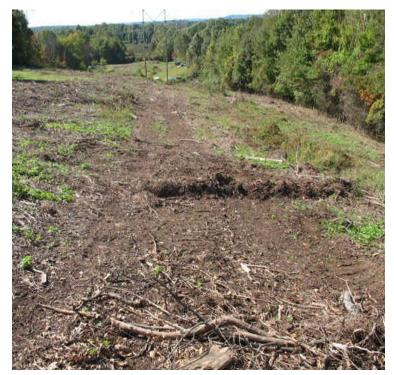
Water bars located on the skidder path off High Hill Rd.

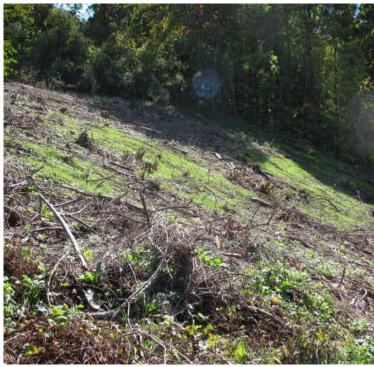
Recently seeded slope off High Hill Rd. Some grass growth is visible.

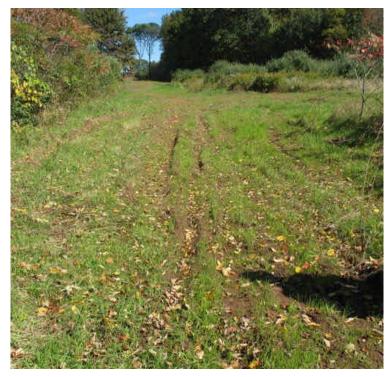
Some grass growth noted off Stony Brook Rd.

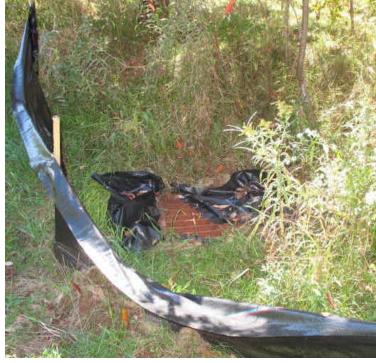
Catch Basin protection off Stony Brook Rd.

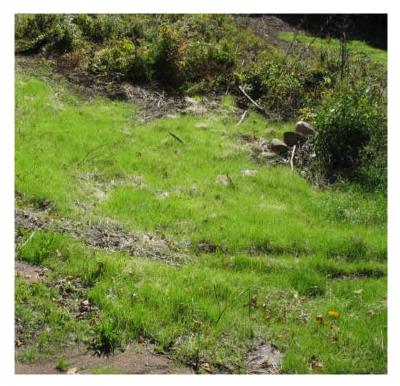
Grass growth noted off Mansion Rd.

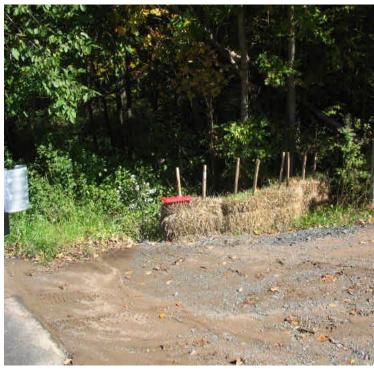
Areas of Inspection	Observation	Recommended Action	Corrected Action
	Grass growth was noted on the steep slope and along the driveway. 10/5/06	Monitor slope for erosion. 10/5/06	Grass growth noted.
	Haybales installed at downgradient edge of the ROW entrance look secure. A few additional haybales should be placed to fully contain any stormwater runoff. No sedimentation has taken place to date. 10/5/06	Monitor and maintain haybales. Add haybales where necessary. 10/5/06	Needs attention when feasible
Old Farm Rd.	Contractor has done an exceptional job selectively removing shrubs and leaving the majority of the vegetation intact. Very little potential for erosion exists in this area. 10/5/06	Continue to selectively cut vegetation in accordance with the D&M plan. 10/5/06	Most vegetation was left in place; this will help prevent erosion.
Inland Wetland and Watercourse encroachment and mitigation	Jurisdictional wetlands and buffers will not be accessed until the ACOE permit is in hand. 8/24- 10/5/06	Continue to monitor wetlands and erosion controls. 10/5/06	NA

Extra haybales are needed to prevent runoff at Mansion Rd. entrance.

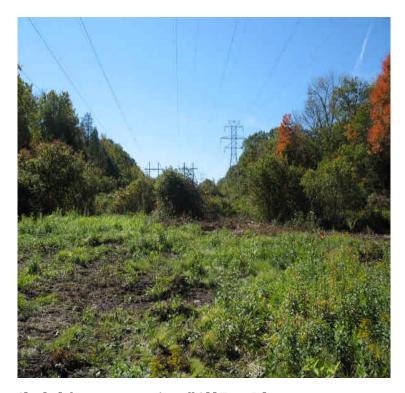
Shrubs left to prevent erosion off Old Farm Rd.

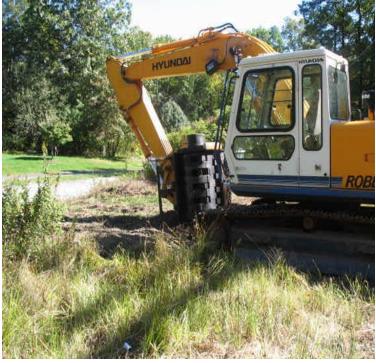
Equipment stored in small, non-jurisdictional wetland finger off Old Farm Rd. should be moved.

Areas of Inspection	Observation	Recommended Action	Corrected Action
	Vegetation was preserved in areas where invasive species were not dominant. 10/5/06	Retain vegetation wherever feasible to reduce disturbance; confirm that cutting is limited only to areas defined in D&M plan. 10/5/06	NA
Dewatering	Dewatering is not being performed at this time. 10/5/06	None	NA
Blasting	No blasting is proposed at this time. 10/5/06	None	NA
Spills, soils and material storage	Cleared trees and shrubs are being stockpiled and chipped on site. 8/24- 10/5/06	Continue to keep all stockpiles set back from wetlands. 8/24-10/5/06	NA
	Spill control materials are being brought to sites when work is performed. 10/5/06	Always use spill control materials when working on equipment and during refueling. Replace as needed. 10/5/06	NA
	A piece of equipment was parked in a small wetland finger off Old Farm Rd. Area is not jurisdictional, and is very small, however, equipment should be moved from the area. 10/5/06	Move equipment upland of this area. Park all heavy equipment away from wetlands and CBs when possible to prevent potential impacts.	Needs attention.
